# Building Inspection Report

**700 Stryker, Jerseyville, Illinois**

**Inspection Date:**  
8/19/2004

**Report Number:**  
040819b

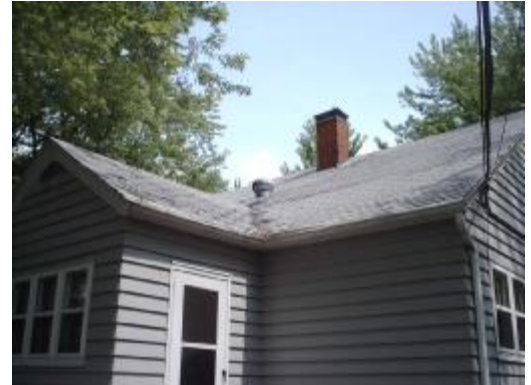
In all, the roof coverings show evidence of normal wear and tear for a home of this age. The roof coverings are old and are at or near the end of their useful life. The roof will probably need to be replaced within five years.

- **Repair:** The roofing is near the end of its life. Minor repairs might be possible to extend the roof life and to defer leaks. Damaged or missing roofing material should be repaired. All roof penetrations should be examined and sealed as necessary. Expect to replace the roof soon.
- Replace the roof flashing materials when re-roofing to avoid leaks in these areas.
- **Monitor:** The masonry chimney shows evidence of normal wear and tear. No repairs are necessary.

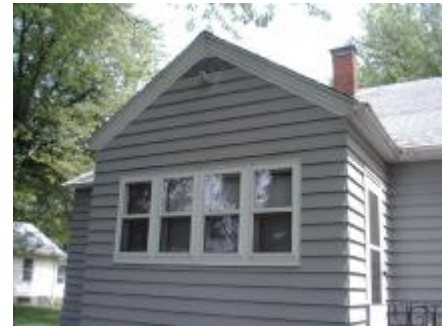
- **Major Concern, Repair:** The wood siding should be painted to preserve the building.

- **Repair:** The soffit and fascia should be painted.

- **Major Concern, Repair:** The window frames require painting and caulking.
- **Repair:** As is very typical, the basement windows have been neglected. They should be repaired or replaced as desired. Wood/soil contact should be avoided to reduce insect and rot-damage risk.

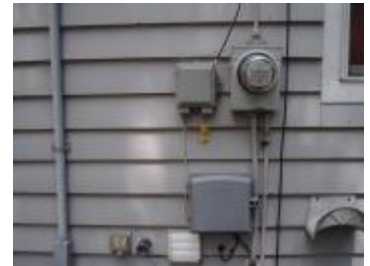
Inspection of the electrical system revealed the need for typical, minor repairs. Although these are not costly to repair, they should be high priority for safety reasons. *Unsafe electrical conditions represent a shock hazard.* A licensed electrician should be consulted to undertake the repairs recommended below. Ground fault circuit interrupter (GFCI) devices have been provided in some areas of the home. These devices are extremely valuable, as they offer an extra level of shock protection. All GFCI's that were tested responded properly.

- **Repair:** Ungrounded 3-prong outlets that were found in the basement stairway, downstairs bedrooms, the rear porch, and the kitchen should be repaired. In some cases a ground wire may be present in the electrical box and simply needs to be connected. If no ground is present "repair" can be as simple as filling the ground slot with epoxy or replacing it with a 2-prong outlet. Better, since having a ground increases safety, a grounded circuit could be strung to this outlet, or a separate ground wire could be connected. Some electrical codes allow the installation of a ground fault circuit interrupter (GFCI) type outlet where grounding is not provided. In this case the GFCI may work but can't be tested by normal means.

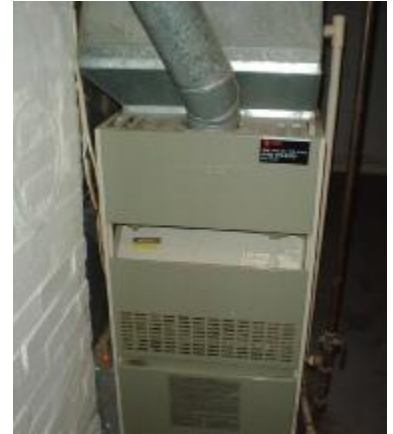
- **Repair:** The humidifier is old and appears to lack maintenance. Cleaning and repairs should be undertaken. Watch out for humidifier leaks into the furnace where costly (and hidden) damage can occur.
- **Improve:** The dirty air filter should be replaced.

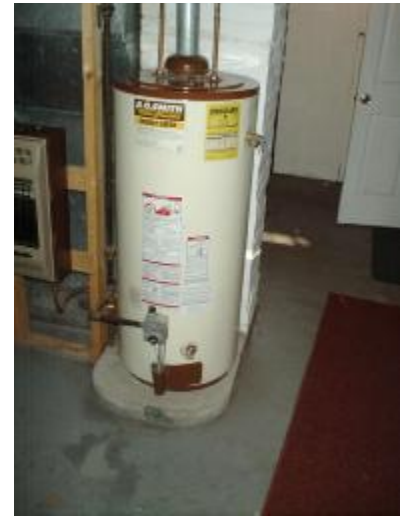
- **Repair:** The discharge piping serving the Temperature and Pressure Relief (TPR) Valve for the water heater should terminate not less than 6 inches or more than 24 inches above the floor.

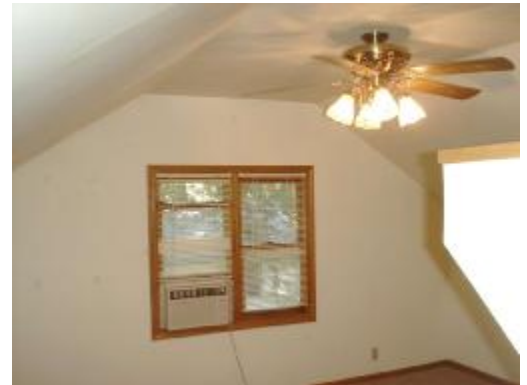
- **Repair:** The windows are in mild disrepair. This is a common condition that does not necessitate immediate major repair. Trimming and adjustment, hardware improvements and glazing repairs would be logical long term improvements. In practice, improvements are usually made on an as needed basis only. The most important factor is that the window exteriors are well-maintained to avoid rot or water infiltration.
- **Repair:** A pane of glass is missing from a window in the main floor rear bedroom.
