Building Inspection Report

1234 Home Drive

Report Number:

20040211

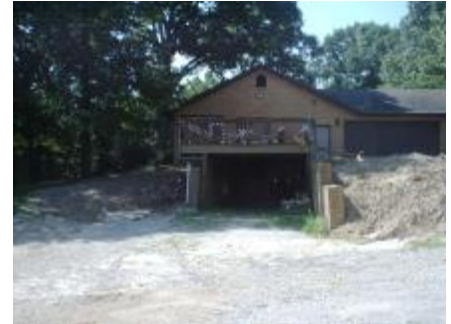
Wall Covering:	•Brick
Eaves, Soffits, And Fascias:	•Aluminum
Exterior Doors:	•Metal •Sliding Glass
Window/Door Frames and Trim:	•Vinyl-Covered
Entry Driveways:	•Concrete
Entry Walkways And Patios:	•Concrete
Porches, Decks, Steps, Railings:	•Treated Wood
Overhead Garage Door(s):	•Steel •Automatic Opener Installed
Surface Drainage:	•Graded Away From House
Retaining Walls:	•Brick

The exterior of the home is generally in good condition.

- **Monitor:** Common minor cracks were observed on the exterior walls of the house. This implies that structural movement has occurred. The location, size, shape of these cracks is common. The inspection did not find evidence of significant movement requiring immediate major repairs.
- **Repair:** Tree branches should be trimmed away from the house.
- **Repair:** The proximity of the tree could disrupt drainage pipes, cause mechanical damage to the exterior of the house, or influence the foundation over time. You should consider removal of the tree.

- **Possible Major Concern, Monitor:** The porch has settled relative to the house proper. This is a common condition that should be monitored. If the porch supports have not already been repaired, replacement may be needed.

- **Monitor:** The retaining wall shows evidence of movement. This condition should be monitored. It is impossible to determine the rate of movement during a one time visit to the house. Trex deck installed above retaining walls should halt any further movement.

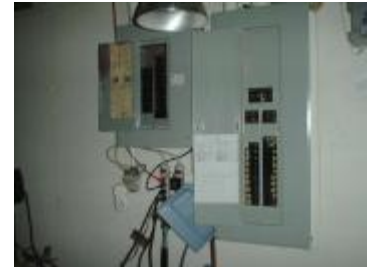
Size of Electrical Service:	•120/240 Volt Main Service - Service Size: 200 Amp
Service Drop:	•Underground
Service Entrance Conductors:	•Copper
Service Equipment & Main Disconnects:	•Main Service Rating 200 Amps •Breakers •Located: Between garage and Laundry
Service Grounding:	•Ground Connection Not Visible
Service Panel & Overcurrent Protection:	•Panel Rating: 200 Amp •Breakers •Located: Basement east end
Sub-Panel(s):	•Panel Rating: 200 Amp •Breakers •Located: Next to main panel
Distribution Wiring:	•Copper
Wiring Method:	• Non-Metallic Cable "Romex"
Switches & Receptacles:	•Grounded
Ground Fault Circuit Interrupters:	•Bathroom(s) •Whirlpool •Exterior •Garage
	•Kitchen
Smoke Detectors:	•Present

The size of the electrical service is sufficient for typical single family needs. The electrical panel is well arranged and all fuses/breakers are properly sized. Generally speaking, the electrical system is in good order. All outlets and light fixtures that were tested operated satisfactorily. The distribution of electricity within the home is good. All 3-prong outlets that were tested were appropriately grounded. Ground fault circuit interrupter (GFCI) devices have been provided in some areas of the home. These devices are extremely valuable, as they offer an extra level of shock protection. All GFCI's that were tested responded properly. Dedicated 220 volt circuits have been provided for all 220 volt appliances within the home. All visible wiring within the home is copper. This is a good quality electrical conductor.

The installation of ground fault circuit interrupter (GFCI) devices is advisable at circuit panel.

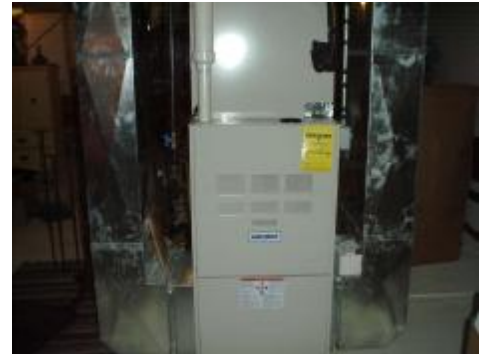
Energy Source:	•Propane
Heating System Type:	•Forced Air Furnace
	•Manufacturer: International Model NTG9125FKA3
	•Serial Number: GNM125N20A3
Vents, Flues, Chimneys:	•Plastic
Heat Distribution Methods:	•Ductwork
Other Components:	•Humidifier

The heating system is in generally good condition. This is a high efficiency heating system. Adequate heating capacity is provided by the system. The heating system is controlled by a “set back” thermostat. This type of thermostat, if set up correctly, helps reduce heating costs.

- **Repair:** The humidifier has lacked maintenance. Cleaning and repairs should be undertaken. Watch out for humidifier leaks into the furnace where costly (and hidden) damage can occur.

- **Repair, Safety Issue:** A return vent is situated relatively close to the furnace. This arrangement is a safety concern, as it could in some conditions send furnace exhaust into the living area, causing a carbon monoxide hazard. A simple repair is to seal off this particular return vent..

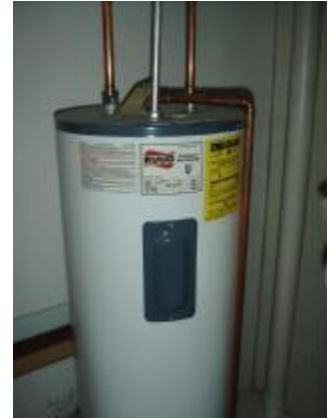
Water Supply Source:	•Public Water Supply
Service Pipe to House:	•Copper
Main Water Valve Location:	•South Side Wall of Basement
Interior Supply Piping:	•Copper
Waste System:	•Private Sewage System
Drain, Waste, & Vent Piping:	•Plastic
Water Heaters(2):	•Electric •Approximate Capacity (in gallons): 50 •Manufacturer: Ruud Model PE52-2C •Serial Number: RU 0999FO3493 & 98
Fuel Shut-Off Valves:	•LP Gas Main Valve At tank

The plumbing system is in generally good condition. The piping system within the home, for both supply and waste, is a good quality system. The water pressure supplied to the fixtures is above average. Only a slight drop in flow was experienced when two fixtures were operated simultaneously. The plumbing fixtures appear to have been well-maintained. The water heater is a relatively new unit. As the typical life expectancy of water heaters is 7 to 12 years, this unit should have several years of remaining life.

- **Repair:** The laundry tub in the basement should be properly secured.

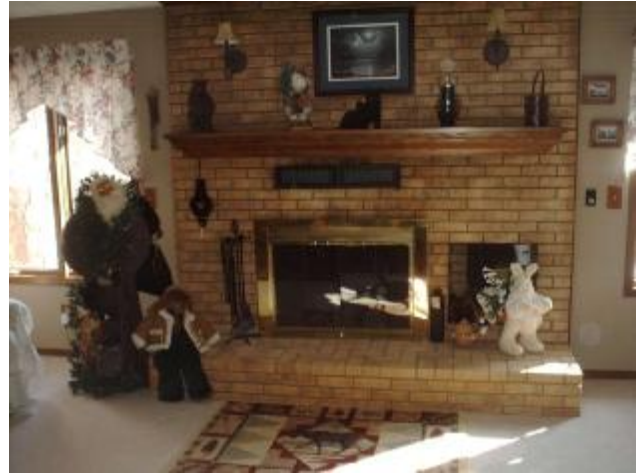
On the whole, the fireplace and it's components are in above average condition. Typical minor flaws were observed in some areas.

- **Repair:** The fireplace chimney should be inspected and cleaned prior to operation.
- **Repair:** The glass doors on the fireplace should be improved.
