# Building Inspection Report

**700 Stryker, Jerseyville, Illinois**

**Inspection Date:**  
8/19/2004

**Report Number:**  
040819b

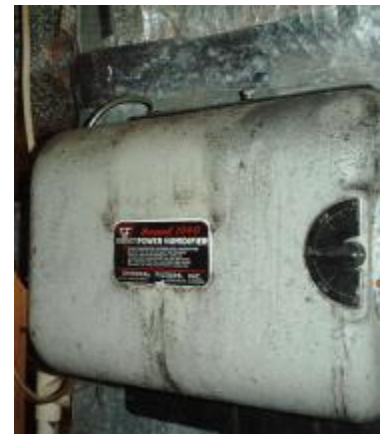
Although the heating system shows no problems, it is always wise to have it checked yearly by a qualified HVAC specialist.

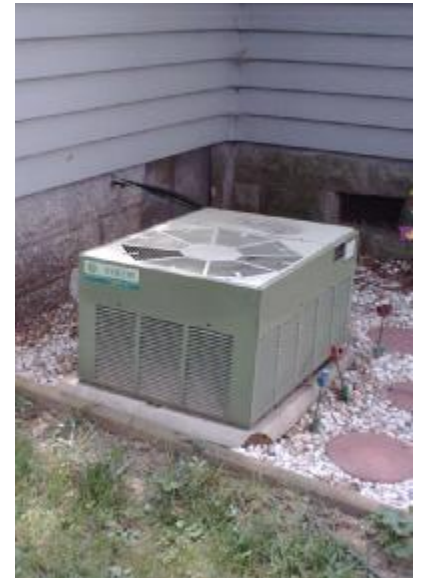
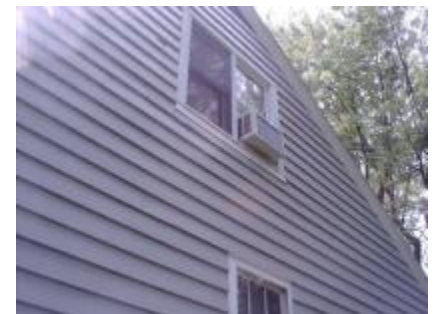
Although the system shows no problems, it is always wise to have it checked by a qualified HVAC specialist.
